# FLORIDA DEPARTMENT OF Environmental Protection

**RE: Warning Letter No. WL21-159**  
**RE: #136246-1100**  
**0 Grove Park Boulevard, Jacksonville, Florida 32216**  
**Site ID No. ERP\_407243**  
**Duval County – Environmental Resource Program**

## ERP Inspection Report

Inspection Date: 7/19/2021

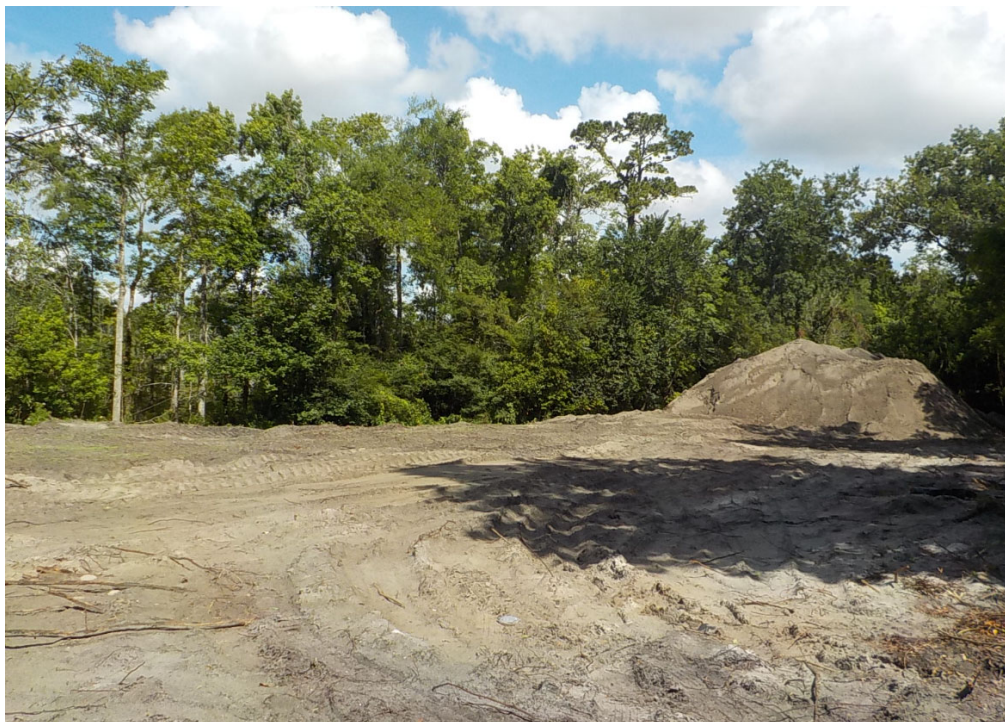
**Figure 1:** 6-8-2021: General site view.

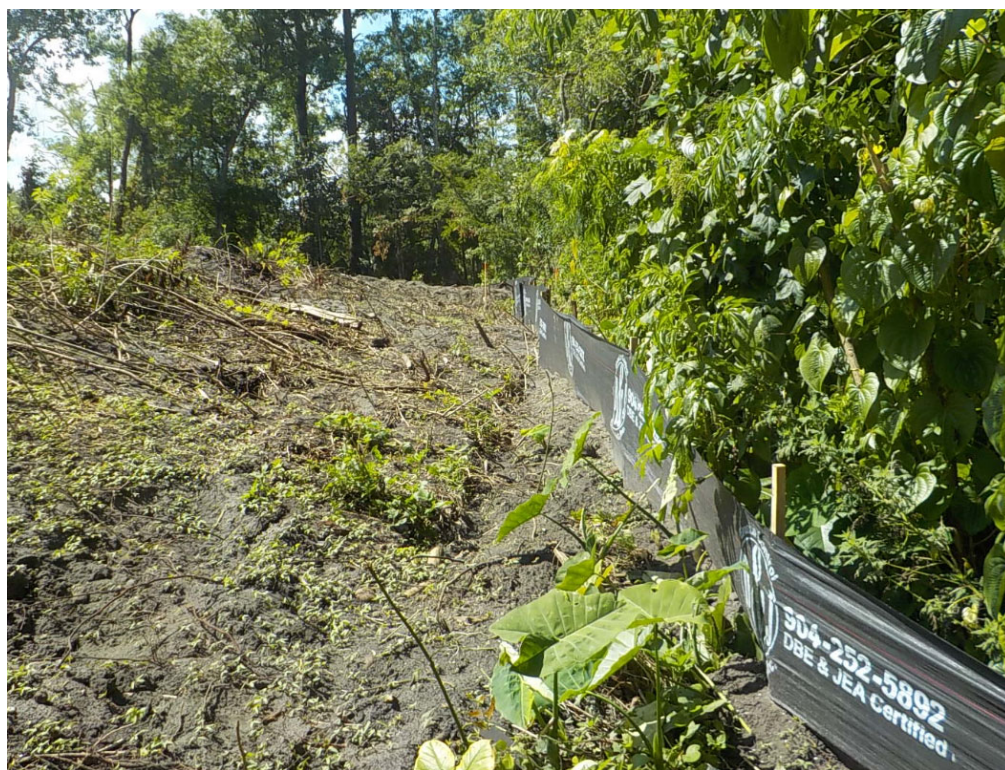
**Figure 2:** 6-8-2021: Silt fence on western Conservation Easement boundary.

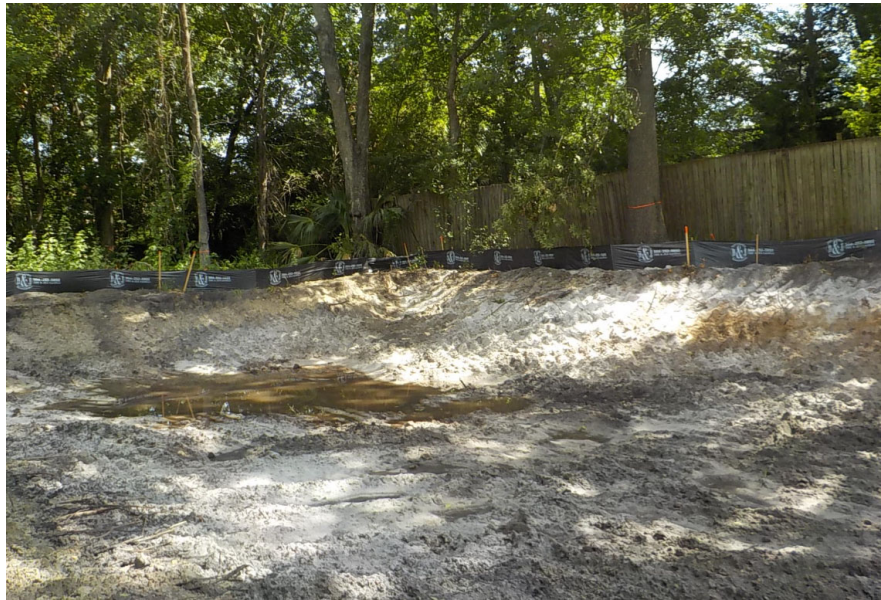
**Figure 3:** 6-8-2021: Excavation on Northeastern portion of the property.

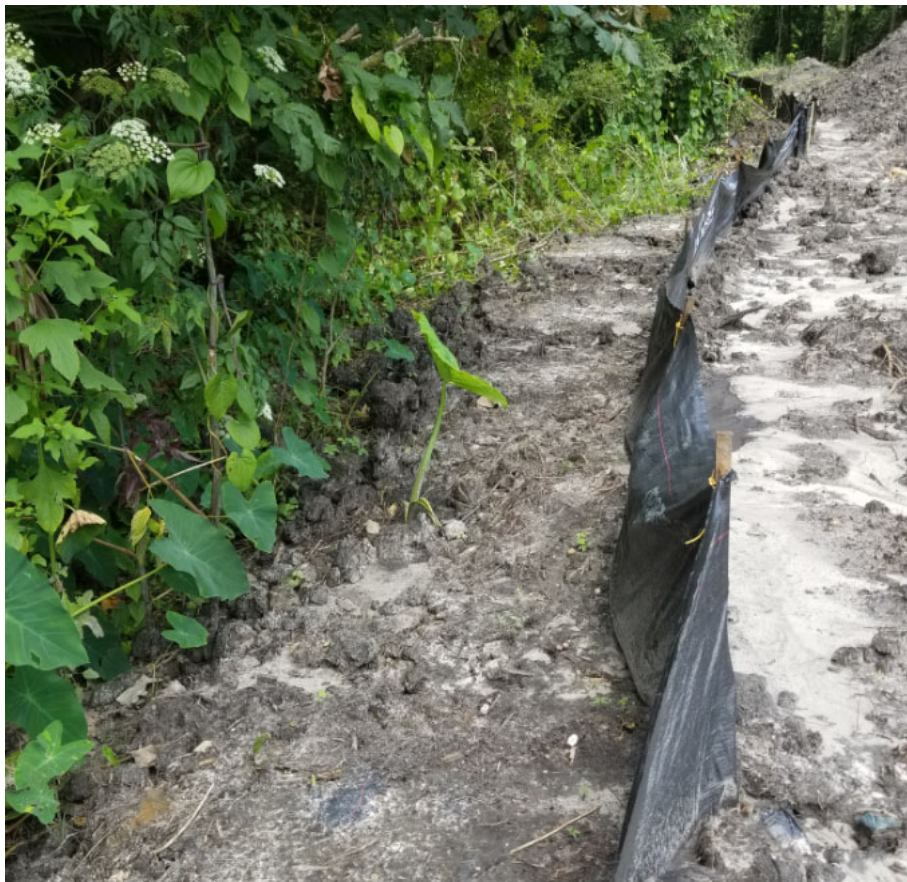
**Figure 4:** 6-29-2021: Muck beyond silt fence on western Conservation Easement boundary.

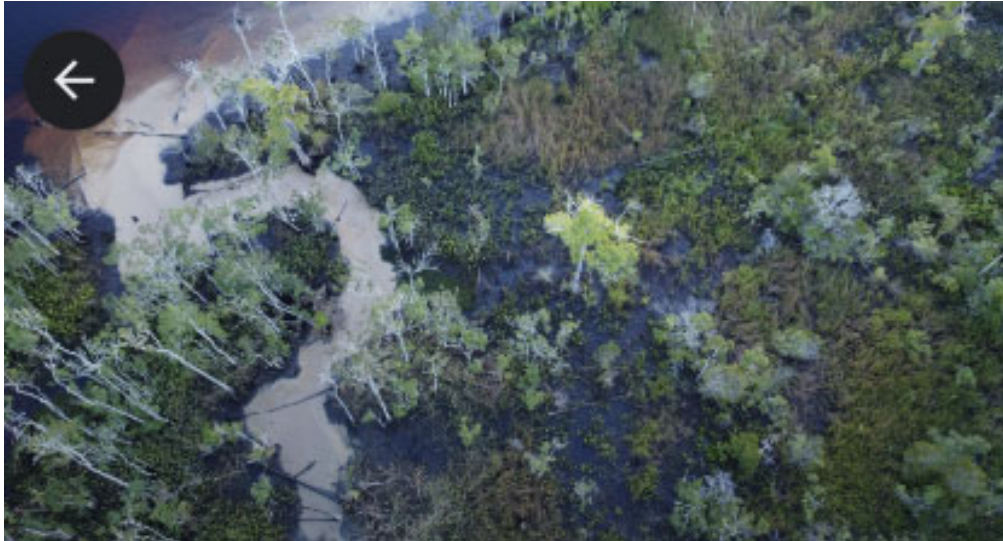
Drone video was received on July 17 and 21, 2021 and documented turbid water being pumped from the project site through the conservation easement wetlands to receiving water Pottsburg Creek. The Department was on-site on July 19 and 20, 2001 and the City of Jacksonville (COJ) was on-site on July 19, 20 and 21, 2021. Department and COJ observed several spots in the silt fence where a discharge hose may have been laid on it.

**Photo 5:** 7-16-2021: Drone photo of turbid water flowing into Pottsburg Creek.

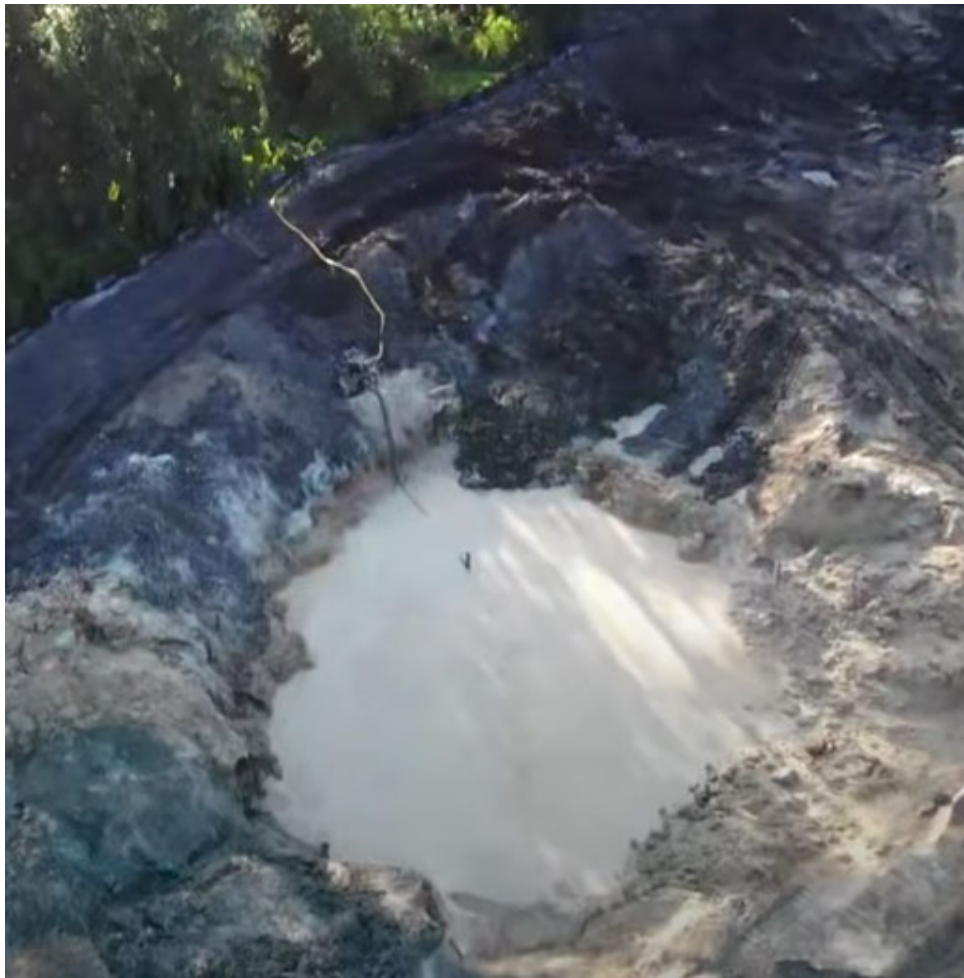
**Photo 6:** 7-16-2021: Drone photo of turbid water being pumped into Pottsburg Creek.

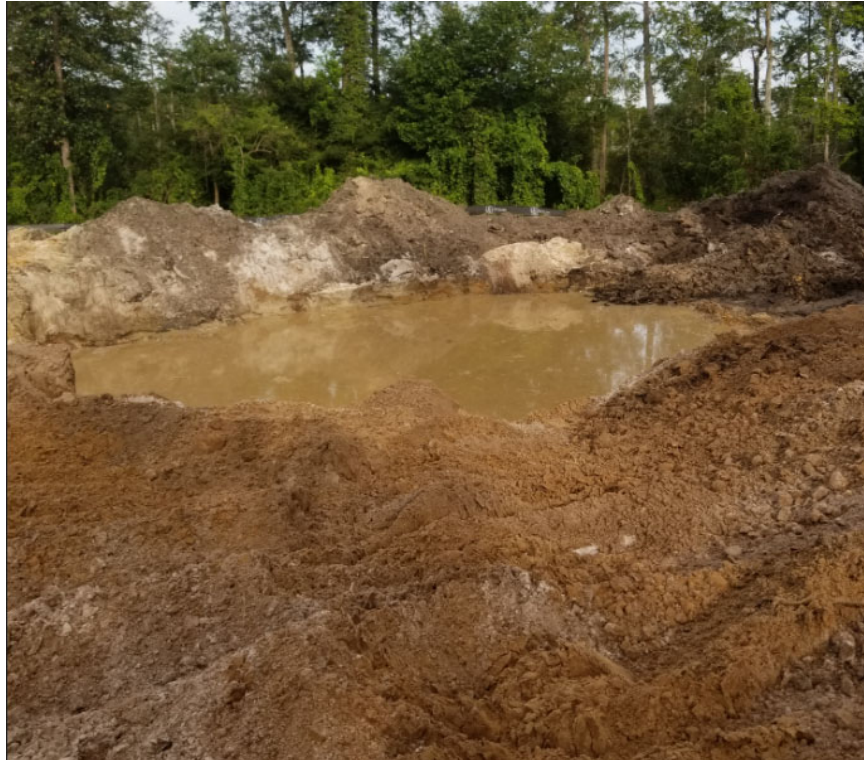
**Photo 7:** 7-19-2021: Northwestern portion of the Property.

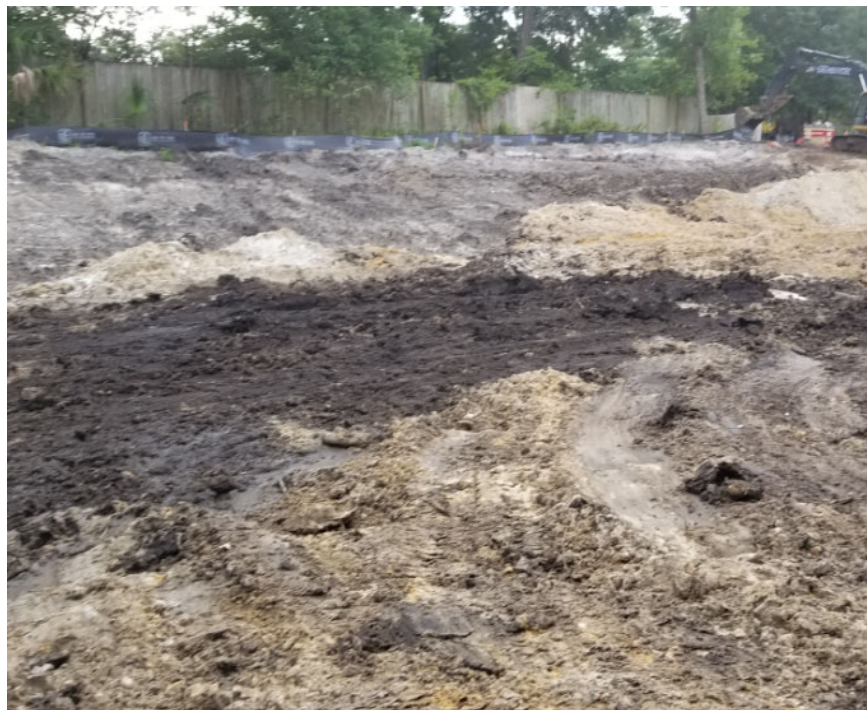
**Photo 8:** 7-19-2021: Muck from Wawa on central portion of the property.

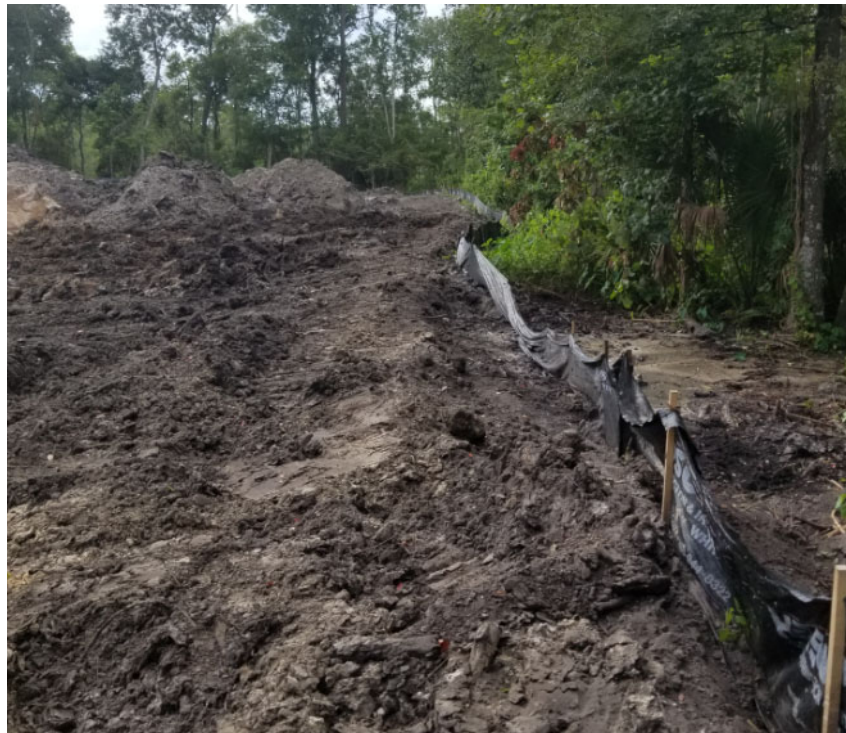
The project activity is in uplands, located adjacent to CE wetlands which leads to Pottsburg Creek as the receiving water. During the July 19, 2021 inspection, we documented where portions of the silt fence between the uplands and the adjacent CE wetlands were crushed down and failed, apparently under the weight of the discharge hose, and the area of discharge had been scoured to some degree. Furthermore, sedimentation was observed outside the perimeter controls within the CE wetlands and a pool of turbid water that appeared to match the turbidity violations presented in the drone footage as well as the area of the pit that had been dewatered was also observed in the CE wetlands.

**Photo 9:** 7-19-2021: Silt fence along western Conservation Easement boundary.

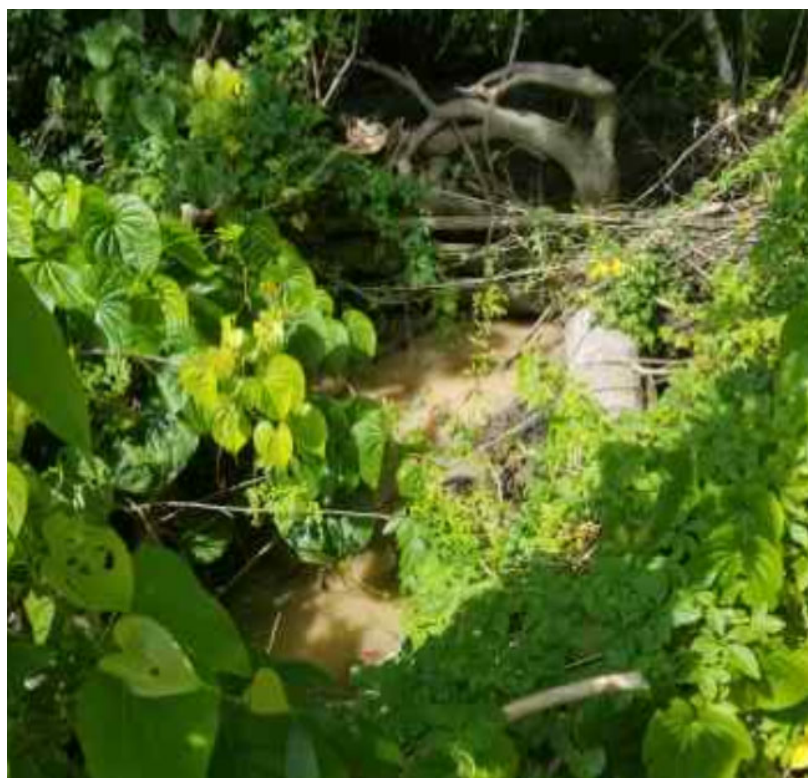
site. COJ provided split samples with the Department as well as Dirt on Demand. The samples for the Department were scanned using a Hatch 2100 Q Turbidimeter. The background sample had a turbidity reading of 28 NTU and the Discharge Point and on-site samples each had turbidity readings of greater than 1,000 NTU.

**Photo 10:** 7-19-2021: Turbid standing water in Conservation Easement.
