SAVe Our River's Grasses *Expedition*

REPORT

PREPARED BY
ST. JOHNS RIVERKEEPER

2024

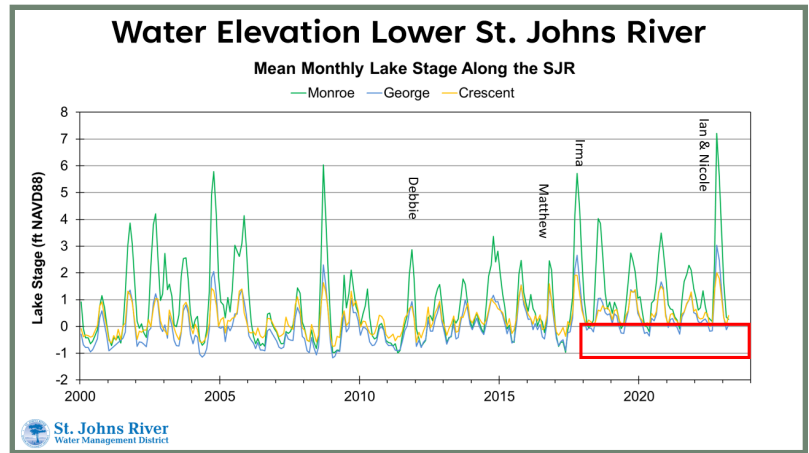
Figure 1. Water elevation of lakes along the Middle and Lower St. Johns River. Note since 2017 minimum elevations have been higher than previous years.

In 2017 Hurricane Irma wiped out SAV from Lake George north through Putnam County to Southern Clay and St. Johns Counties. The typical flow rate of the St. Johns River is between 2-11 billion gallons/day, depending on drought and flood conditions. During Irma, the flow rate hit 88 billion gallons/day; this rate may not even represent the maximum, however, as the gauge on the Acosta Bridge was rendered inoperable after this measurement. More than 90% of the SAV was lost after Hurricane Irma and the stressors continue to stunt the return of the grasses.

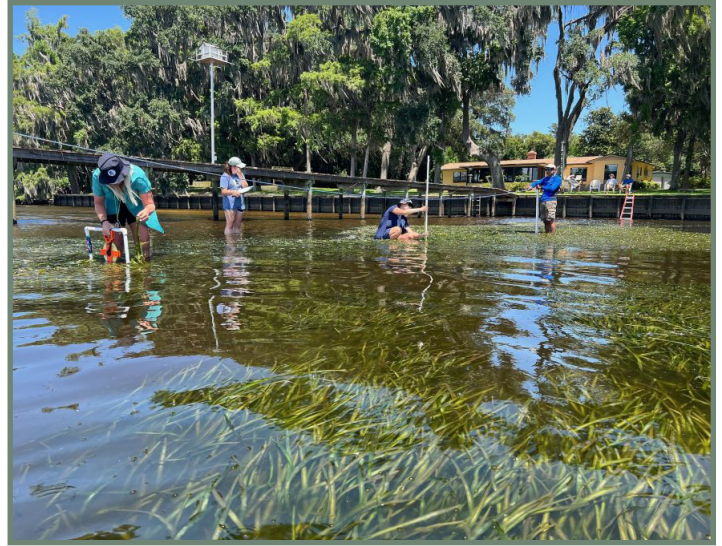
SITE 6: DANCY POINT

May 2023 vs. 2024: Inside the enclosure in May 2024, the team surveyed the highest grass bed density at this site at 66% and the highest average canopy height at 54 cm. In May 2023, the site had only 29% density and an average canopy height of 2.38 cm. Outside of the enclosure, while the SAV was still short and chopped due to evident grazing pressure, there were signs of improvement. The average canopy height increased to 3.44 cm from 1.3 cm last May, and the average density rose to 21% from 19% May 2023.

August 2023 vs. 2024: In August 2024, the average canopy height inside the enclosure showed a dramatic increase, averaging 50 cm compared to just 6.39 cm in August 2023. The grass bed density also improved, reaching an average of 71% this year, up from 63% last August. Outside the enclosure, canopy height also saw progress, with an average of 4 cm this year compared to 1.45 cm in 2023.

- Scouring of the littoral zone, which directly rips up SAV
- To make matters worse, the protective enclosure located at Dancy Point in East Palatka was compromised in early September. The eel grass that once reached historic conditions succumbed to grazer pressure in approximately three week's time and was reduced to stubble by our October field survey.

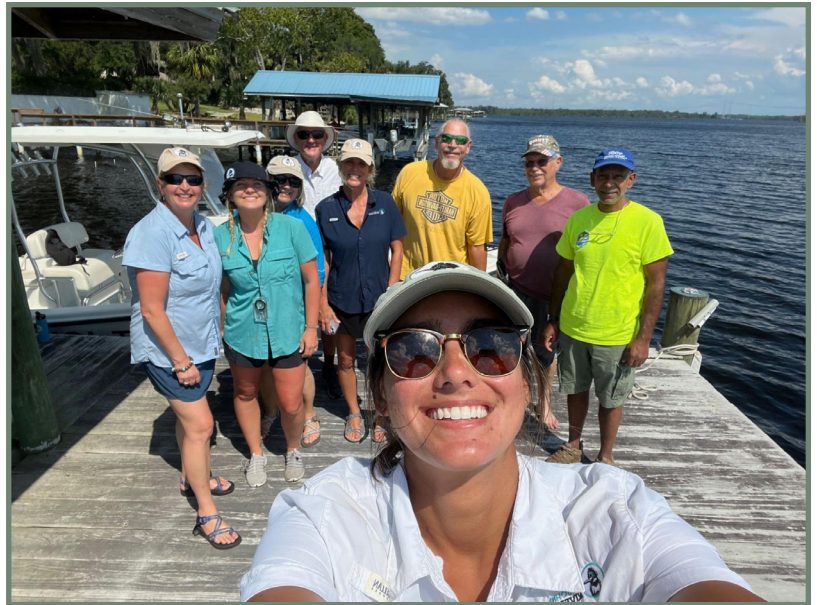
SITE 8: SAN MATEO

Site 8 is at the property of Tim Houghtaling and Leslie Mullins, who have lived on the east bank of the St. Johns River in Putnam County since 2013. Their property has a metal bulkhead. Tim is actively advocating for more protections of our river's grasses. In March 2022, he installed his first fenced enclosure similar to Site 6 - Dancy Point, but on a smaller scale. Inside the fence the SJRK team found primarily eelgrass. The team also identified aquatic sponges that were encapsulating some of the eelgrass.

May 2023 vs. 2024: We were pleased to see long, healthy eelgrass beds during our May 2024 visit. Average canopy height reached 12.9 cm compared to 2.27 cm in May 2023. Grassbed density was robust at 78% compared to 51% in 2023.

August 2023 vs. 2024: Unfortunately, during our August Field Visit, the team noticed an algae bloom and was unable to safely conduct an SAV survey and transect. Results from the lab revealed potentially toxic (PTOX) *Microcystis* sp. (> 600 colonies/mL), *Raphidiopsis raciborskii* (> 400 filaments/mL) and *Dolichospermum* sp. (> 60 filaments/mL). In August of 2023, canopy height reached 5 cm and grassbed density was 51%.

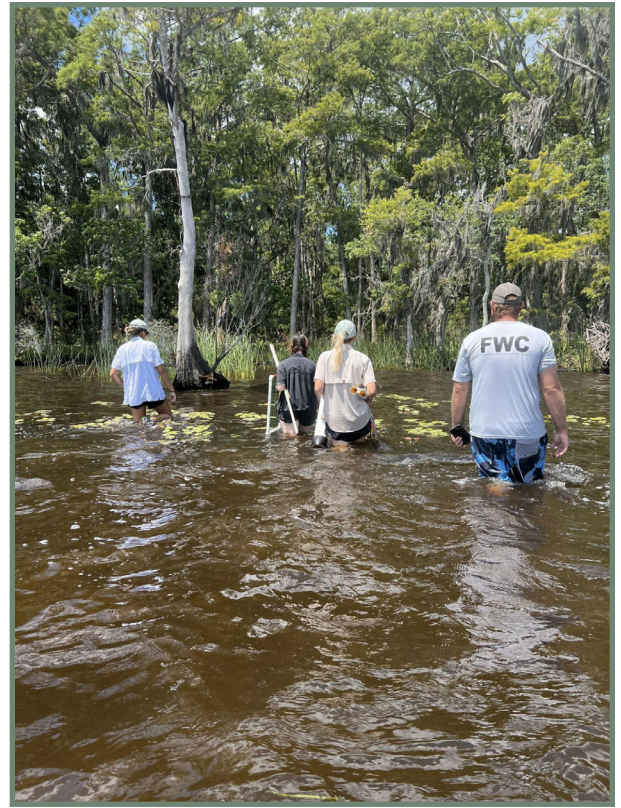
2. Dancy Point

Installed in February 2023, the Dancy Point enclosure showed promising results within just 3 months. By May 2023, SAV began to sprout, reaching an average canopy height of 2.38 cm and a grassbed density of 29%. Growth accelerated over the summer, with the eelgrass averaging 6.39 cm in height and a 63% grassbed density by August. By October 2023, the eelgrass reached an impressive average height of 45.5 cm, with the grassbed density holding steady.

Unfortunately, the enclosure at Dancy Point was compromised in early September 2024. This breach left the once-thriving eelgrass vulnerable to grazer pressure, leading to its rapid decline. Within three weeks, the previously lush beds were reduced to stubble, as observed during our October field survey.

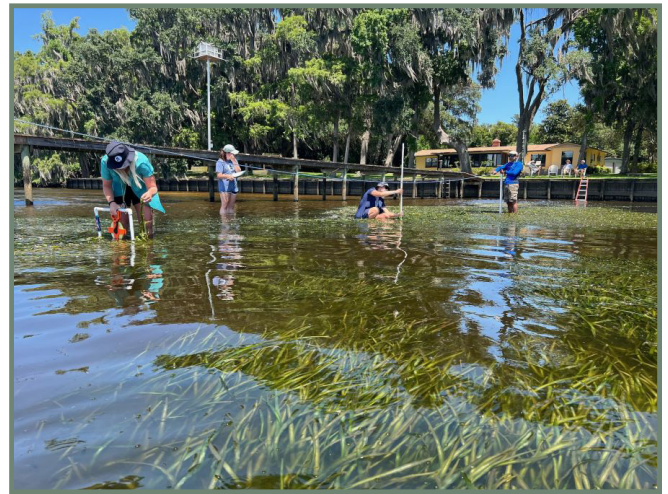
By May 2024, the eelgrass inside the enclosure achieved even greater heights, averaging 54 cm, with a percent cover of 66%. Growth remained consistent through August, with the canopy height staying similar and grassbed density increasing to 71%.
