SAVE Our River's Grasses Expedition

REPORT

PREPARED BY
ST. JOHNS RIVERKEEPER

2025

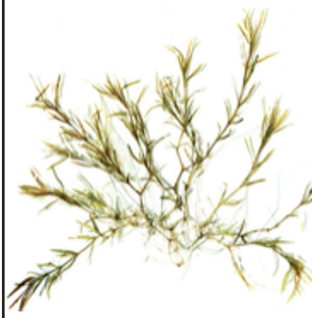
<i>Ruppia maritima</i>	Widgeon grass	<ul style="list-style-type: none"> • Leaves alternate along the stem and taper to a slender tip • Leaves are thread-like, approximately 0.5 mm wide • Plant height ranges from 4 to 20 cm

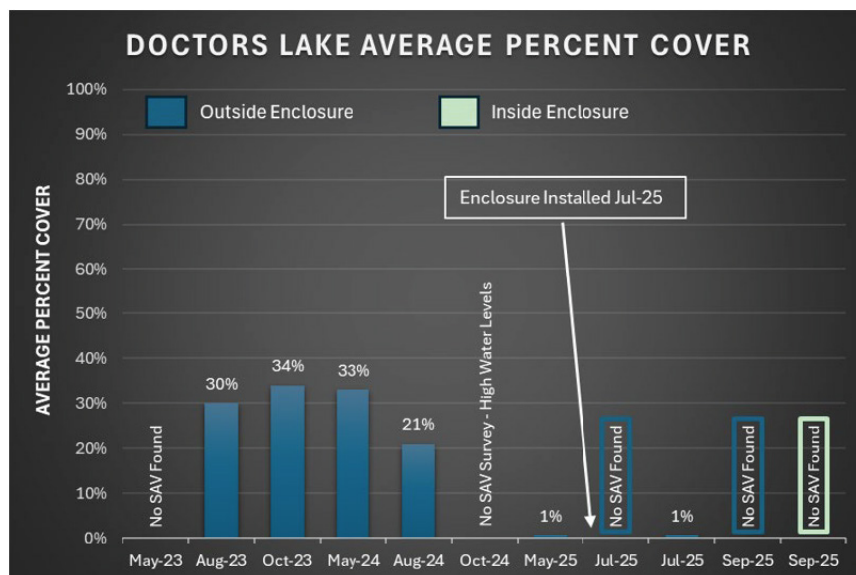
Figure 3: Doctors Lake Average Percent Cover

May: In May 2023, no SAV was present coinciding with high salinity levels. May 2024 showed improved percent cover at approximately 33%, but by May 2025, cover had decreased to a mere 1%. ***Overall, comparative May-May conditions appear to show decreased percent cover from 2023-2025.***

August & July: The percent cover in August 2024 was slightly less than 2023, averaging 21% compared to 30%. 2025's sampling occurred in July rather than August, in an attempt to reduce exposure to potentially toxic algae. Five days prior to the July 2025 sampling, a protective enclosure was installed. Unfortunately, outside the enclosure still showed no SAV, but inside the enclosure SAV showed a preliminary attempt at recovery, exhibiting 1% cover. ***Overall, comparative August/July conditions appear to show decreased percent cover from 2023-2025.***

October & September: October 2023's percent cover was 34%, but as previously mentioned, consecutive hurricanes in September and October of 2024 resulted in the decimation of SAV and the surrounding littoral zone in 2024. A preliminary sweep for SAV yielded no discovery. SAV was likewise absent in September 2025, both inside and outside the enclosure. ***Overall, comparative October/September conditions appear to show decreased percent cover from 2023-2025.***

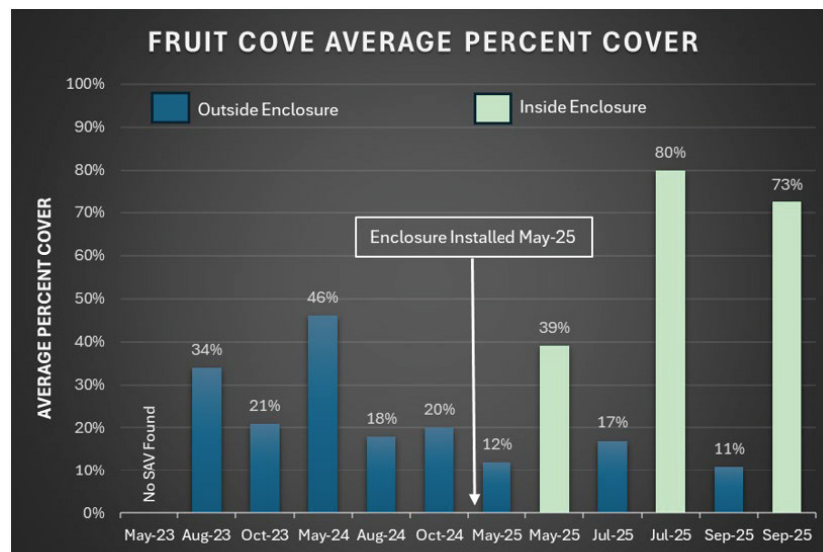
Figure 10: Fruit Cove Average Percent Cover

Percent cover at this site has generally remained low (0%-46%) from 2023-2024, with minor fluctuations observed across sampling months and years, until the installation of the protective enclosure when coverage improved inside the enclosure (39%-80%). Following the most recent sampling event, **the overall trend appears to be improving inside the enclosure and worsening outside the enclosure.**

May: In May 2023, no SAV was present. May 2024's percent cover improved to 46%, but May 2025's cover decreased to 12% (see Fig. 10). This could have resulted from a slow recovery after 2024's hurricane season. The protective enclosure at the Fruit Cove site was installed on May 1, 2025, and early results inside the enclosure showed great improvement compared to outside the enclosure: while outside was a mere 12%, inside showed a much improved 39%. **Overall, comparative May-May conditions appear to show stable percent cover from 2023-2025.**

sure, percent cover showed great improvement at 80%. **Overall, comparative August/July conditions appear to show decreased percent cover outside the enclosure and increased coverage inside the enclosure from 2023-2025.**

October & September: October percent cover remained consistently low at 21% and 20% for 2023 and 2024, respectively. However, after four months of enclosure presence, percent cover showed remarkable improvement in the protected area. Outside the enclosure, cover remained low at 11%. Inside the enclosure, percent cover increased substantially to 73%. **Overall, comparative October/September conditions appear to show increased canopy height and species diversity both inside and outside the enclosure from 2023-2025.**

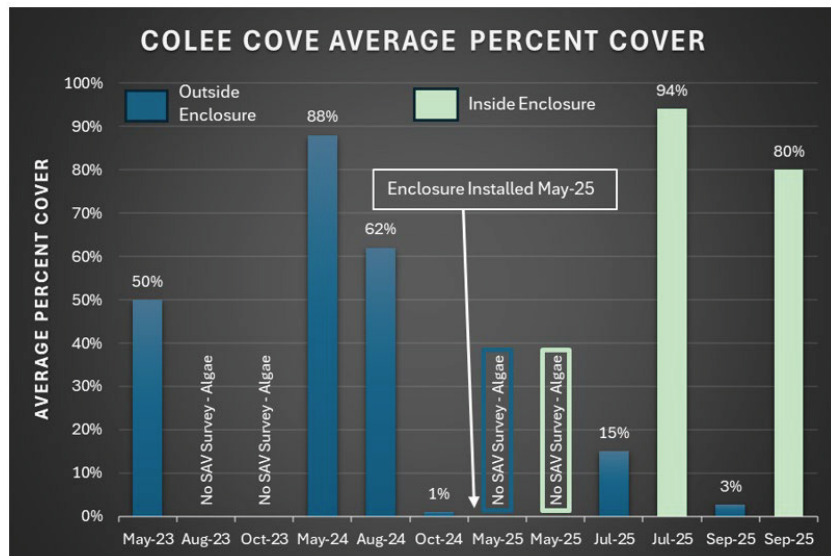
Figure 20: Colee Cove Average Percent Cover

October & September: Due to algal presence, an October 2023 SAV survey was not conducted. In October 2024, back-to-back hurricanes, compounded with other stressors, decimated percent cover to 1%. Outside the enclosure, percent cover was 3% in September 2025, compared to 15% in July 2025. Inside the enclosure, percent cover remained robust at 80%. **Overall, comparative October/September conditions show minimal cover outside the enclosure and nearly full coverage inside the enclosure 2024-2025 (October 2023 survey was not conducted due to algae).**

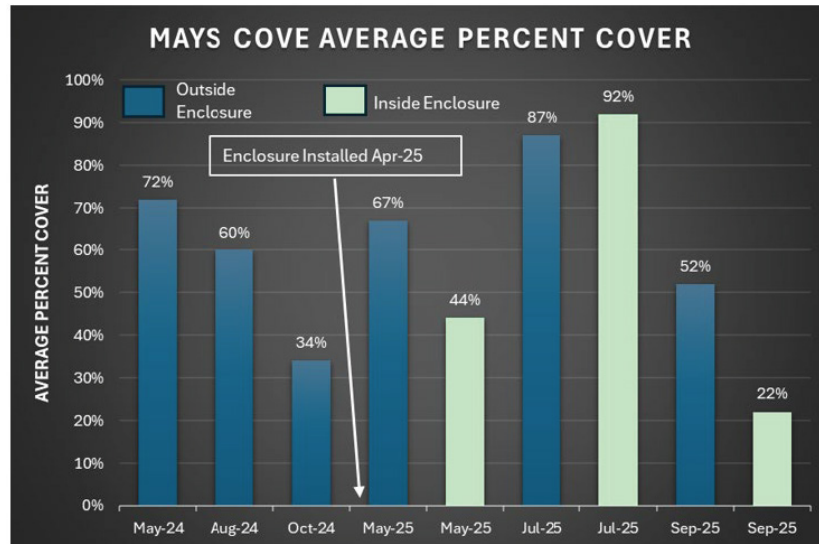
Figure 25: Mays Cove Average Percent Cover

October & September: As previously mentioned, the 2024 hurricane season was underscored by back to back hurricanes. Unsurprisingly, the percent cover was reduced from 72% and 60% in May and August, respectively, to 34% in October. In September of 2025, percent cover had again decreased compared to 2 months prior. Outside the enclosure, coverage was reduced to 52%, and inside the enclosure was even less at 22%. This was somewhat surprising, as both species diversity and canopy heights were more improved inside the enclosure. This demonstrates the complex nature of enclosure dynamics and potential SAV stressors. **Overall, comparative October/September conditions appear to show increased percent cover outside and decreased percent cover inside the enclosure from 2024-2025.**
